## Prognosis and evaluation of tooth damage caused by implant fixtures

**Abstract** (J Korean Assoc Oral Maxillofac Surg 2013;39:144-147)

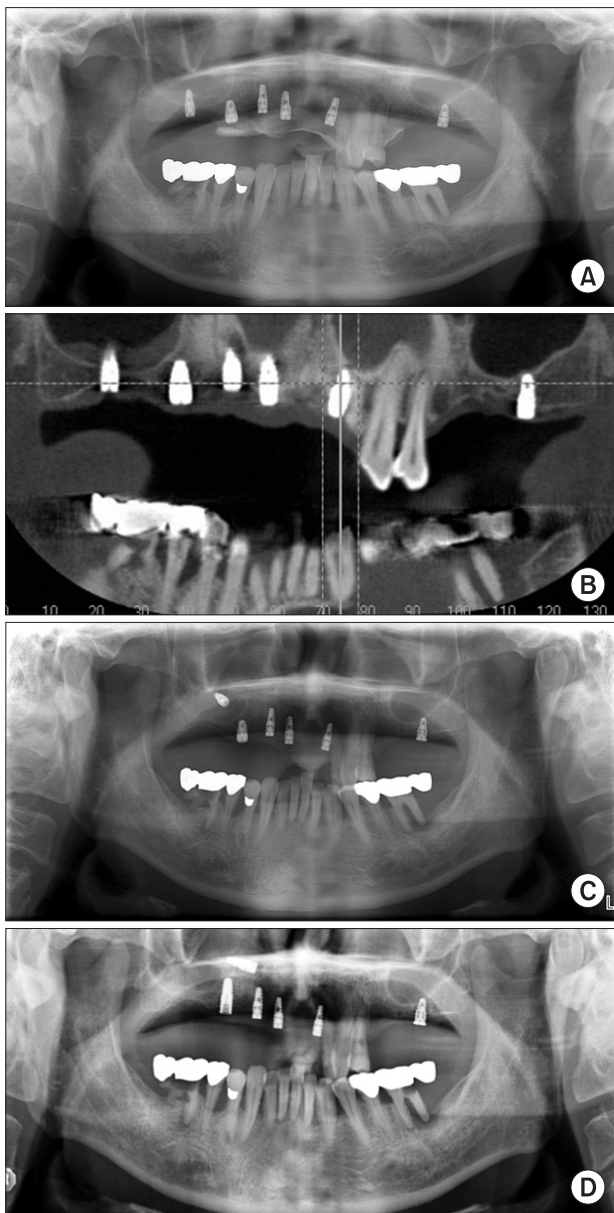
**Fig. 1.** Radiographic findings. A, B. Immediately after installation. C. After 6 months. D. After 18 months.

A 63-year-old male patient visited our hospital with chief complaint of uncomfortable current maxillary removable partial denture. There were no special findings in his medical history. Including the immediate implant placement after the extraction of tooth #13, implants were placed in 6 areas (#17, #14, #13, #11, #21, and #27). On the postsurgical panoramic radiographs and computed tomography images, the implant (DAS, 3.8×10 mm; DAS Tech, Gwangju, Korea) placed in #21 was observed to be tilted to the distal side and positioned

closely to the adjacent #22.(Figs. 1. A, 1. B) The fixture did not affect the adjacent periodontal ligament space, however. The implant stability quotient (ISQ) using Osstell Mentor (Integration Diagnostics AB, Göteborg, Sweden) was 67. #22 did not show specific clinical and radiological findings.

The follow-up radiographs taken 6 and 18 months after surgery showed no extraordinary findings in the periradicular area of the natural adjacent tooth.(Figs. 1. C, 1. D)

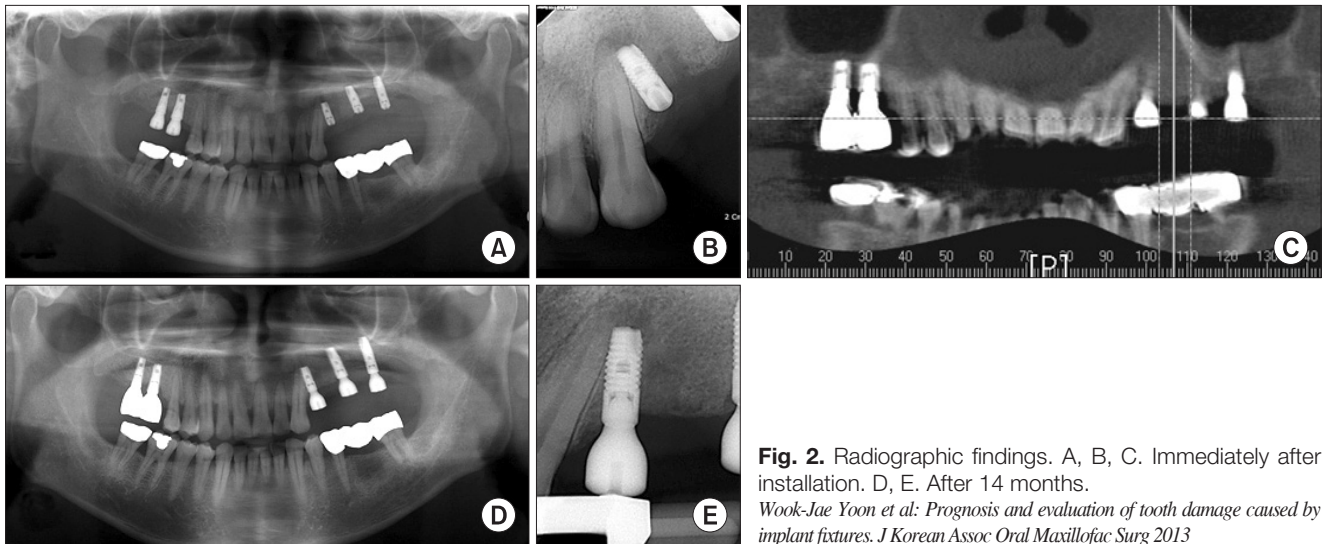
**Fig. 2.** Radiographic findings. A, B, C. Immediately after installation. D, E. After 14 months.  
 Wook-Jae Yoon et al: Prognosis and evaluation of tooth damage caused by implant fixtures. J Korean Assoc Oral Maxillofac Surg 2013

A 55-year-old male patient visited our hospital primarily requiring repair of the implant placed in the missing maxillary molar area. According to his medical history, he had diabetes, which was controlled with medication. Clinical and radiological tests revealed the loss of several maxillary molars (#16, 17, 25, 26, and 27). The left maxillary first premolar (#24) showed a residual root with periradicular inflammation. On the day of the visit, the root was extracted. Because of the patient's personal situation, 18 months passed before an implant was placed in the corresponding area (Astra, 3.5×9.0 mm; OsseoSpeed TX, Astra Tech AB, Mölndal, Sweden), and allogenic bone graft (Allomatrix; Wright Medical Technology Inc., Arlington, TN, USA) was performed simultaneously. ISQ using Osstell Mentor was 72. Nonetheless, the fixture was observed to be located very close to the adjacent tooth (#23).(Figs. 2. A-2. C) In addition, radiolucency was noted in the periradicular area of the fixture. The radiographs taken 14 months later showed that its size was not changed.(Figs. 2. D, 2. E) There were no specific clinical findings in the adjacent natural teeth. After 1 year, the Periotest value (PTV) using PerioTest C (Medizintechnik Gulden, Hessen, Germany) was -4.

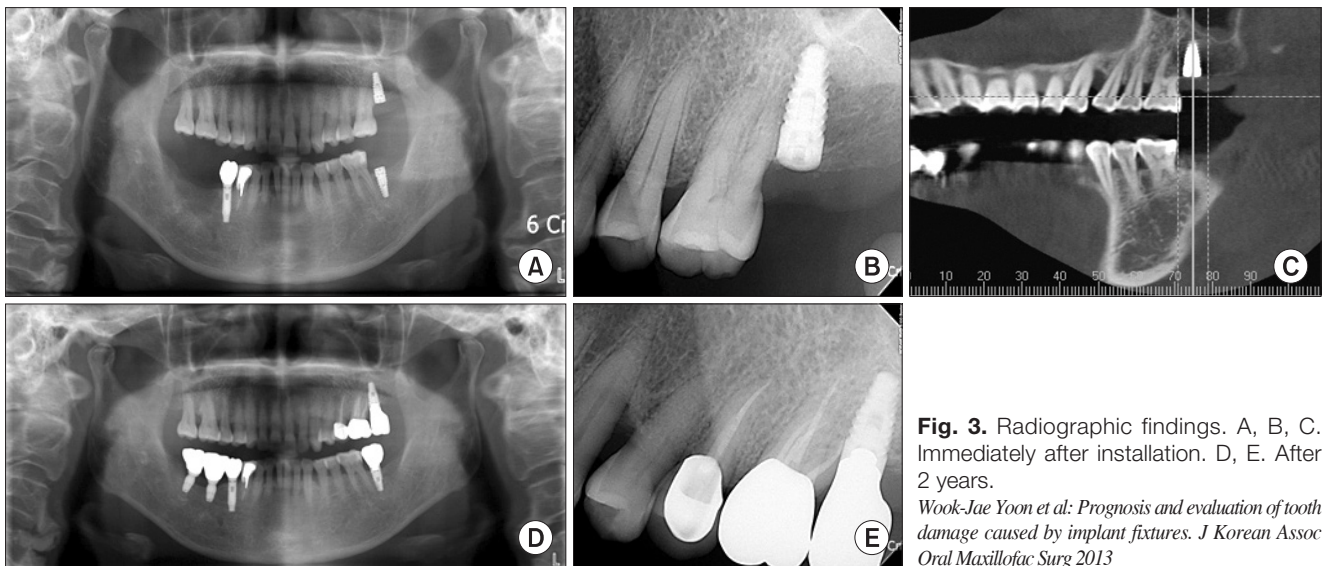
**Fig. 3.** Radiographic findings. A, B, C. Immediately after installation. D, E. After 2 years.  
 Wook-Jae Yoon et al: Prognosis and evaluation of tooth damage caused by implant fixtures. J Korean Assoc Oral Maxillofac Surg 2013

An implant was placed in a 62-year-old female patient due to the loss of the left maxillary second molar (#27) (Biohorizon, 4.6×10.5 mm; Biohorizons Implant Systems Inc., Birmingham, AL, USA). PTV was 7, which was slightly low. In addition, the postsurgical radiographs showed that, due to the dilaceration of the adjacent natural tooth, the fixture was located near the left maxillary first molar.(Figs. 3. A-3. C) A second surgery was performed after 9 months. PTV was -6 (PerioTest C), and ISQ was 84, which were good levels. One year after surgery, endodontic treatments were performed to resolve hypersensitivity symptoms caused by the fall-out of the prosthesis in the mesial area of the adjacent natural tooth (#26) but were not associated with a fixture placed nearby. The follow-up radiographs did not show special findings.(Figs. 3. D, 3. E)
